**NOTICE OF MEETING  
ECONOMIC DEVELOPMENT CORPORATION**

**March 10, 2026**

1. Consider approval of PEDC Minutes from February 10, 2026.
2. Consider approval of PEDC Minutes from February 20, 2026.
3. Presentation by Jeremy Rowden in regards to the Wetlands Delineation Study for the PEDC Rail Park Property.
4. Discussion and possible action regarding a Second Amendment to a Downtown Grant Performance Agreement between PEDC and Cecil Staples.

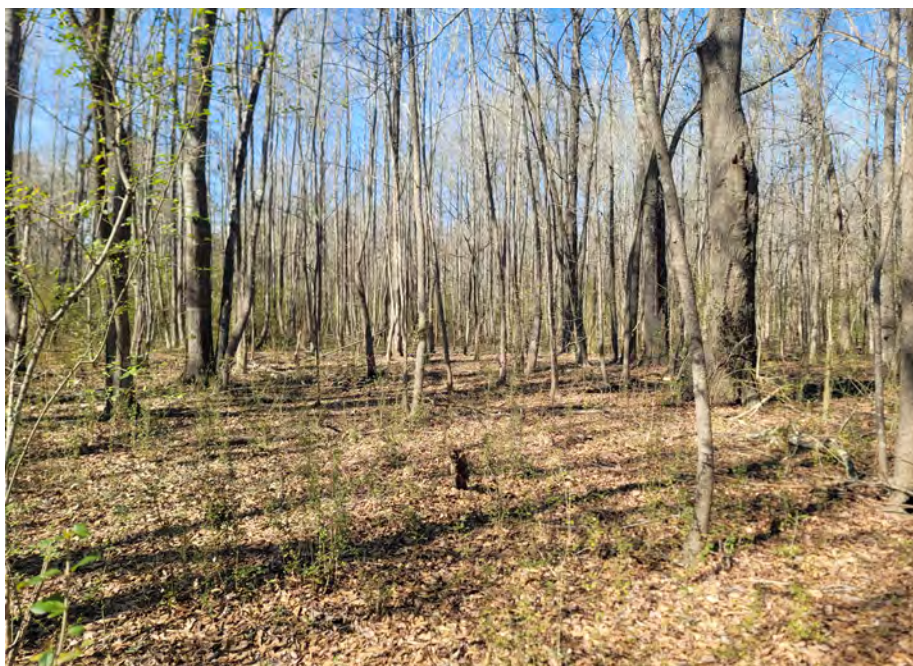
**8**

View of mesic (non-wetland) conditions at Plot 2.

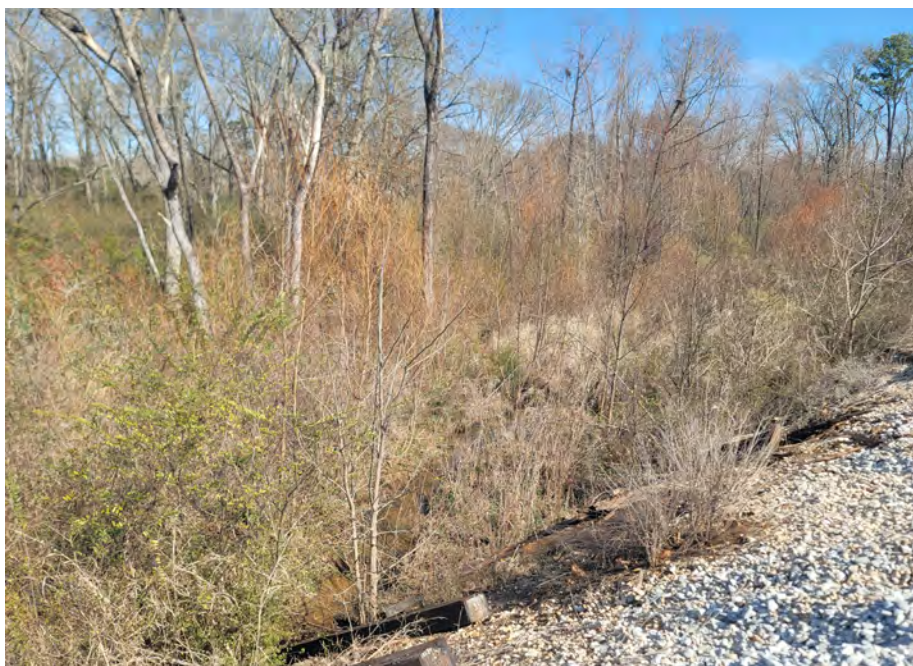
**14**

View of an intermittent stream (RPW) on the southwest side of the property with riparian wetlands.

A second, smaller intermittent stream was identified on the southwest side of the property. Stream flows were very slight, and the channel is likely to cease flowing during dry months. As such, the channel on the southwest side of the property that drains through wetlands and a small pond was found to exhibit an intermittent flow regime that is considered to be relatively permanent, at least seasonally.

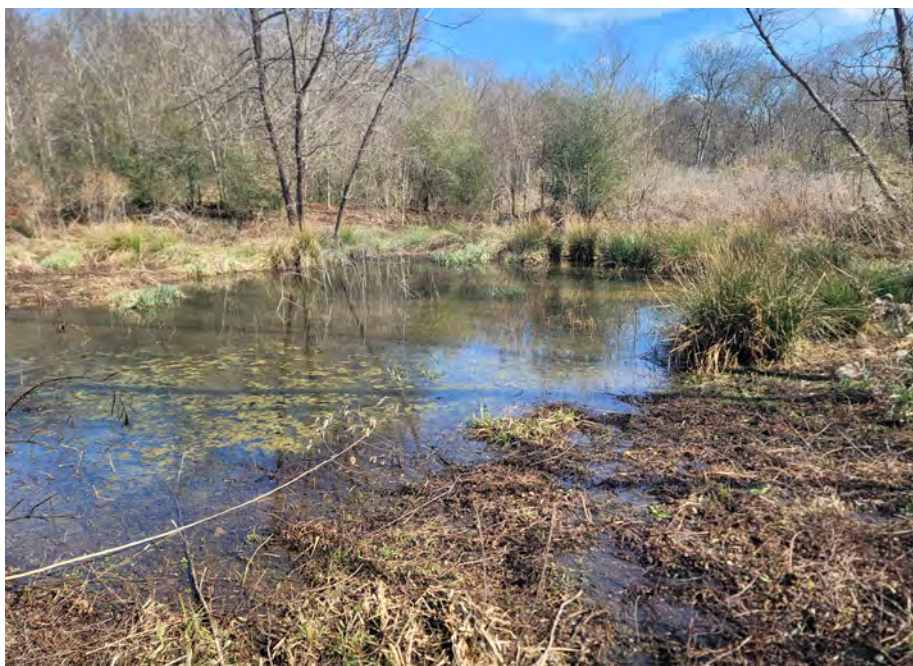
**16**

View of an on-channel pond on the southwest side of the property.

One small pond was observed within the drainage path of the smaller intermittent stream on the southwest side of the property. The pond was constructed as an impoundment of the stream. The pond’s current open water status and impoundment upon current waters of the U.S. makes the pond subject to regulation under Section 404 and is also considered to be waters of the U.S.

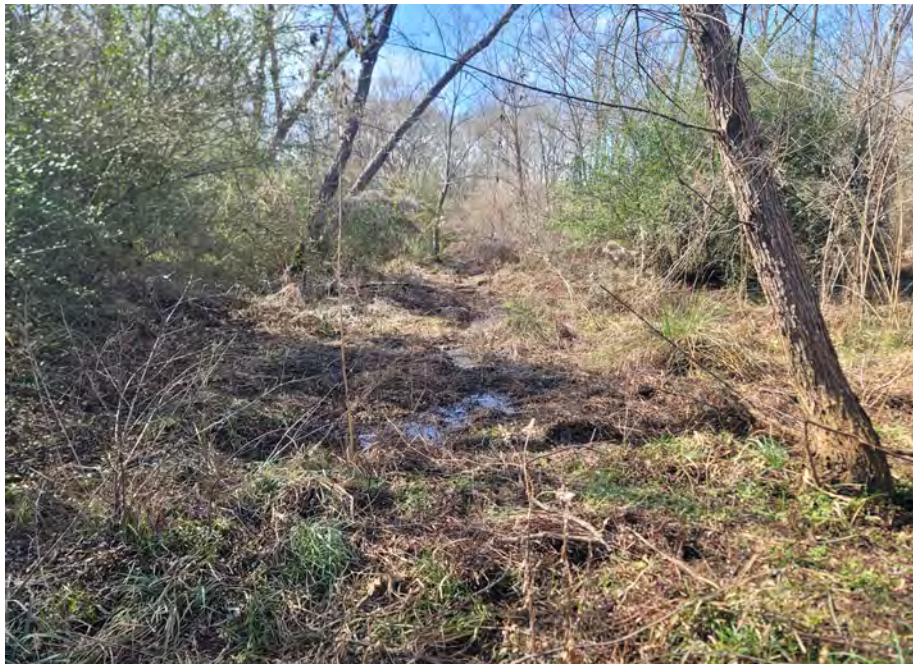
**17**

View of wetlands near Plot 3.

Plot 3 was established in a linear wetland on the southwest side of the property. The presence of poorly drained terrain and a dammed pond appear to support wetland conditions in this area. Vegetation at Plot 3 was represented by American elm (*Ulmus americana*), black willow (*Salix nigra*), sweetgum, tall goldenrod (*Solidago gigantea*), soft rush (*Juncus effusus*), rattlepod (*Sesbania drummondii*), and smartweed (*Persicaria hydropiperoides*). The area of Plot 3 exhibited a dominance of facultative hydrophytes, which satisfied wetlands criteria for vegetation. Hydric soils and wetland hydrology were also confirmed.

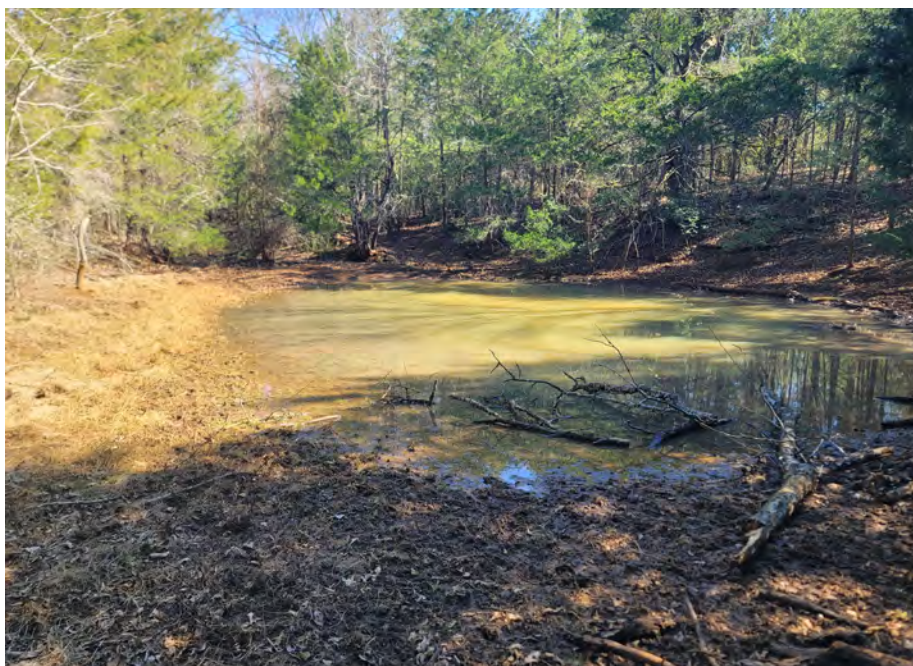
**32**

View of an upland man-made pond constructed on unregulated waters on the north side of the property.

Two open water ponds were observed on the northeast side of the property. Both ponds were impounded on non-RPWs. The ponds are not impoundments of waters of the U.S., and they are considered to be isolated ponds that are nonjurisdictional. Upland man-made ponds that were not constructed within other regulated waters have been unregulated since the January 2001 decision by the U.S. Supreme Court in *Solid Waste Agency of Northern Cook County (SWANCC) v. USACE*, which disallowed regulation of isolated wetlands and ponds under the Clean Water Act through the “Migratory Bird Rule.” Previously, the USACE assumed jurisdiction over isolated waters based on its 1986 preamble stating that migratory birds used these habitats. However, the SWANCC case clarified that ponds must have been impounded on regulated waters in order to be jurisdictional. No Section 404 permit should be required to fill or disturb the ponds identified on the property.

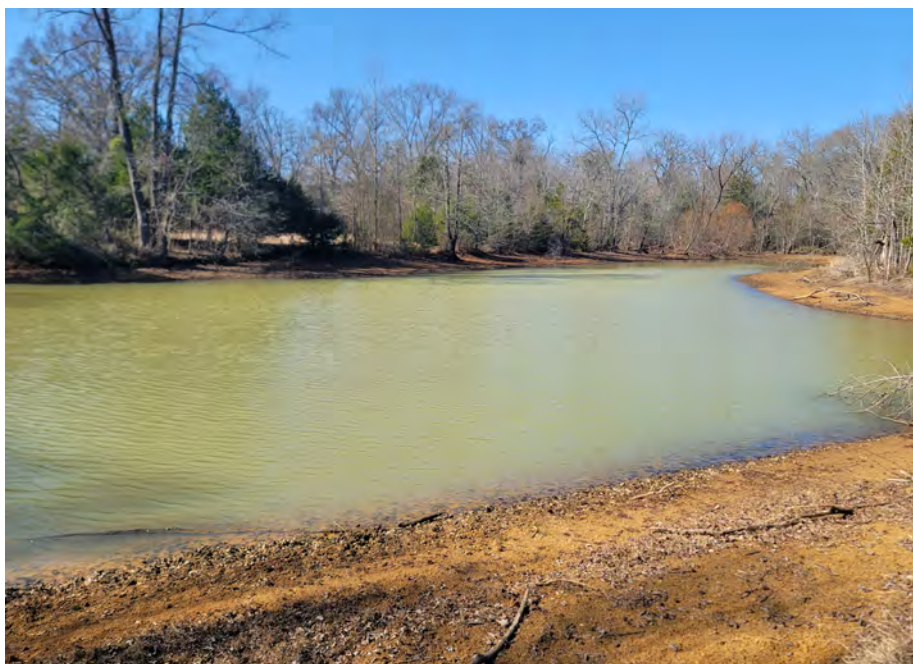
**36**

View of an upland man-made pond constructed on unregulated waters on the east side of the property.

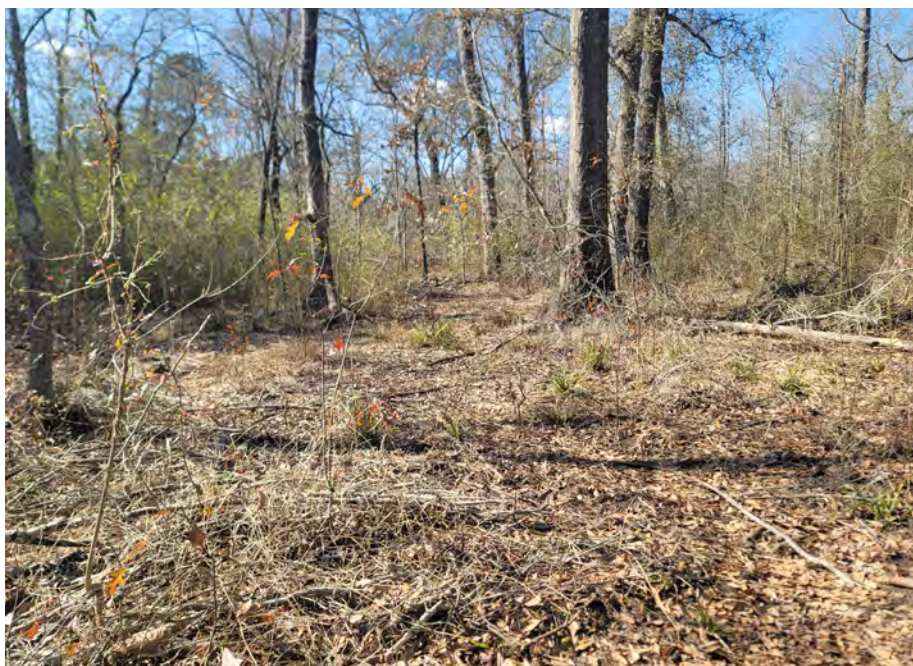
**40**

View of wetland conditions at Plot 6.

Plot 6 was established in a flat, linear wetland identified on the south side of the property. Vegetation at Plot 6 was represented by water oak, soft rush, smartweed, and tall flatsedge (*Cyperus eragrostis*). The area of Plot 6 exhibited a dominance of facultative hydrophytes, which satisfied wetlands criteria for vegetation. Hydric soils and wetland hydrology were also confirmed. Note that this area does not appear to meet the “continuous surface connection” requirement for wetland regulation, as described in the Jurisdictional Determination section below.

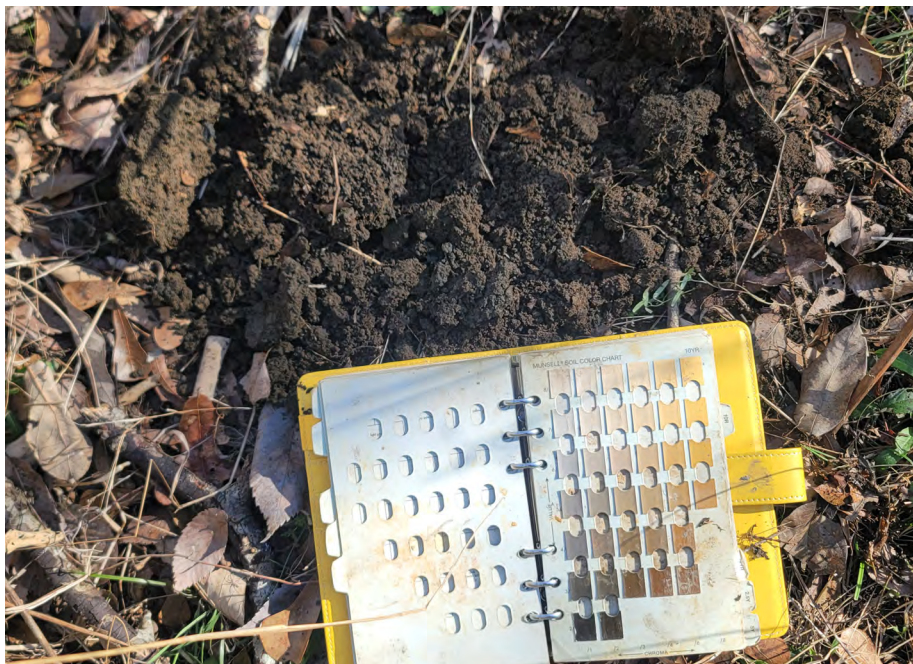
### Plot 1

View of the non-hydric soil profile at Plot 1.

Plot 1 was established on a stream terrace near an intermittent stream on the north side of the property. Munsell soil colors observed throughout the diagnostic horizons of the sample plot were 10YR 2/2 without redoximorphic features, which did not satisfy hydric soil criteria. Plot 2 was established on wide, flat area that exhibited mesic characteristics. Munsell soil colors observed throughout the diagnostic horizons of the sample plot were 10YR 2/2 and 10YR 3/2 without redoximorphic features, which did not satisfy wetlands criteria for hydric soils. Plot 3 was established in a linear wetland on the southwest side of the property. Munsell soil colors observed throughout the diagnostic horizons of the sample plot were 10YR 3/2 with redoximorphic features, which satisfied hydric soil criteria as a redox dark surface. Plot 4 was established beyond the boundary of the wetland identified at Plot 3. Munsell soil colors observed throughout the diagnostic horizons of the sample plot were 7.5YR 3/2 and 4/4 without redoximorphic features, which did not satisfy hydric soil criteria.

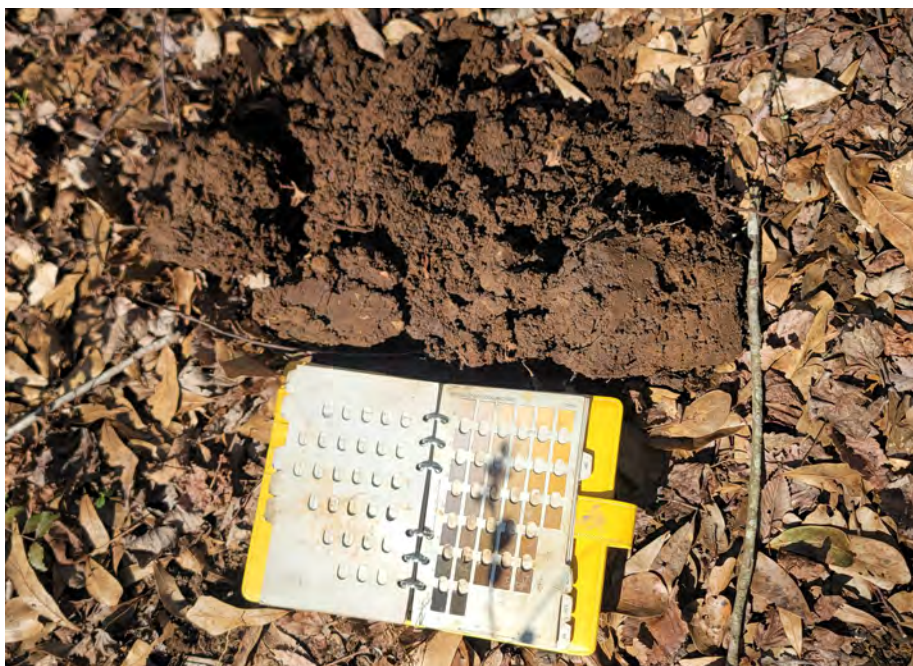
### Plot 2

View of the non-hydric soil profile at Plot 2.

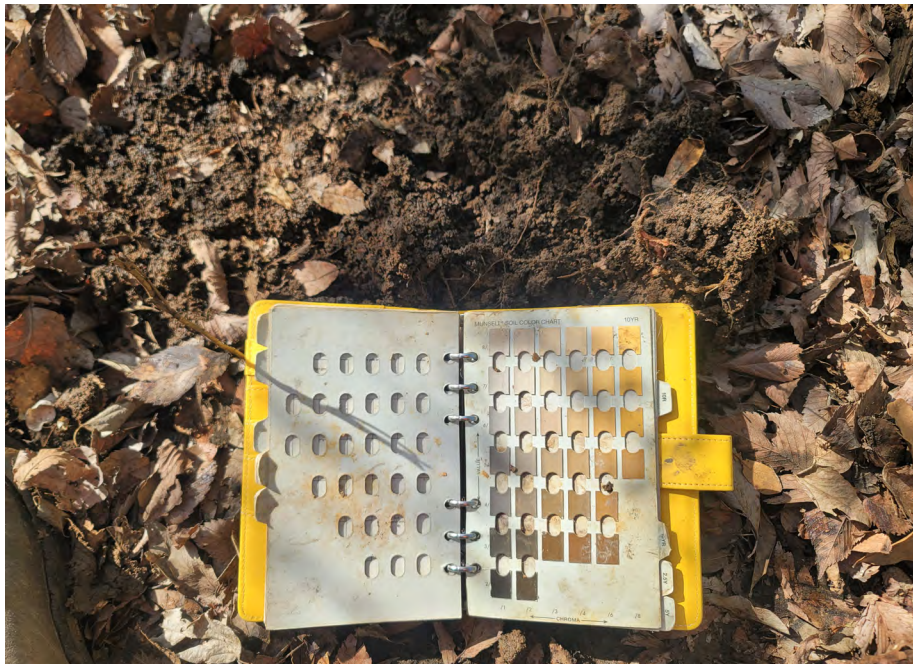
### Plot 5

View of the hydric soil profile at Plot 5. Soils were also observed to be saturated.

Plot 5 was established in a floodplain wetland on the south side of the property. Historical aerial photographs show this area to have once been inundated, but inundation does not appear to be a frequent occurrence. Munsell soil colors observed throughout the diagnostic horizons of the sample plot were 10YR 2/2 with redoximorphic features, which satisfied hydric soil criteria as a redox dark surface. Plot 6 was established in a flat, linear wetland identified on the south side of the property. Munsell soil colors observed throughout the diagnostic horizons of the sample plot were 10YR 2/2 (surface) and 10YR 5/2 with redoximorphic features, which satisfied hydric soil criteria as a depleted matrix. Plot 7 was established beyond the boundary of the wetland identified at Plot 6. Munsell soil colors observed throughout the diagnostic horizons of the sample plot were 10YR 3/3 and 4/3, which did not satisfy hydric soil criteria. Plot 8 was established beyond the boundary of the wetland identified at Plot 5 within the floodplain of a perennial stream. The plot was established on an elevation gradient slightly higher than that of Plot 5. Munsell soil colors observed throughout the diagnostic horizons of the sample plot were 10YR 3/2 without redoximorphic features, which did not satisfy hydric soil criteria.

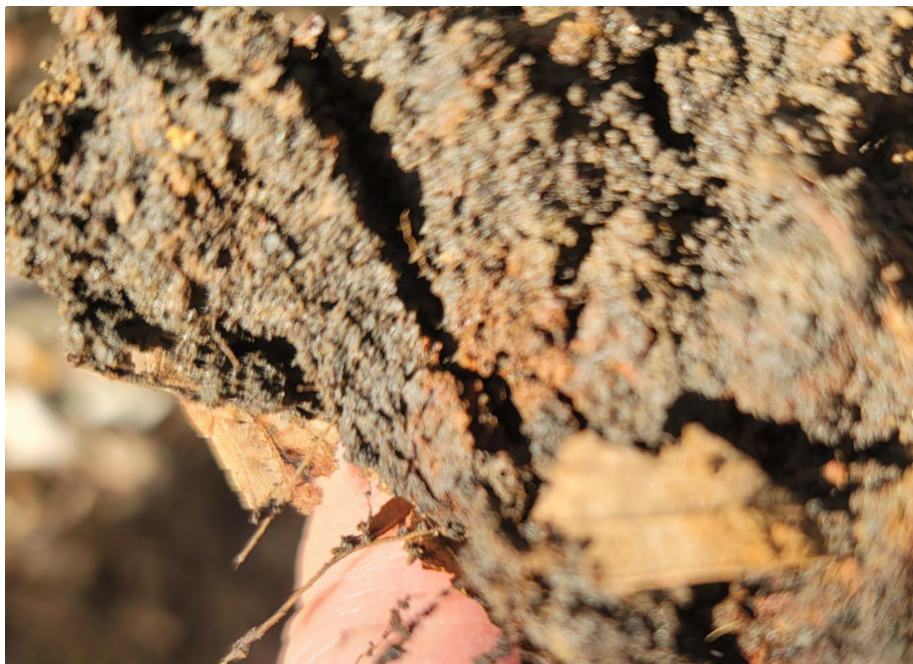
### Plot 6

View of redoximorphic features in a depleted matrix taken from hydric soils at Plot 6.

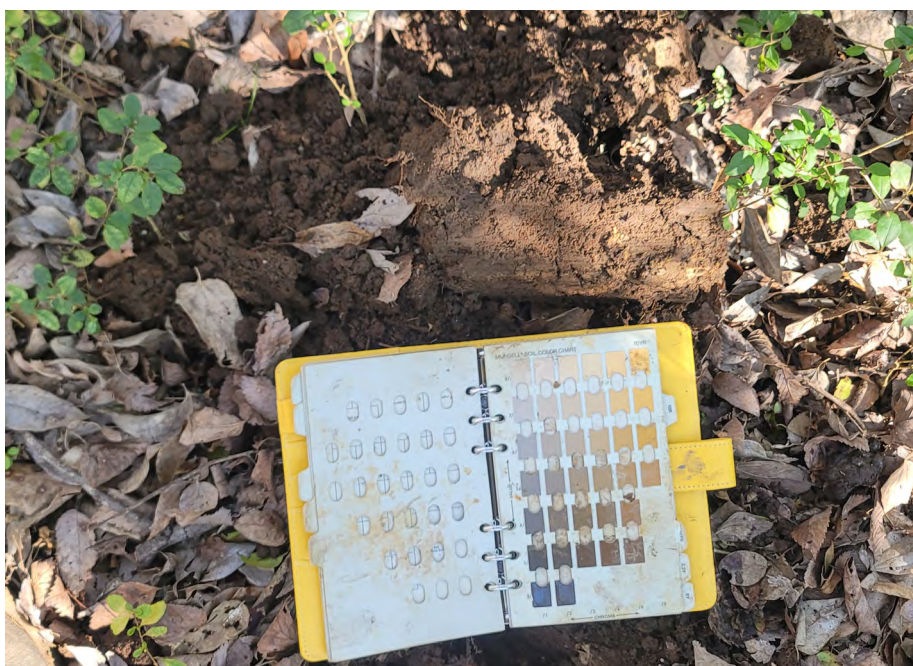
### Plot 8

View of the non-hydric soil profile at Plot 8.

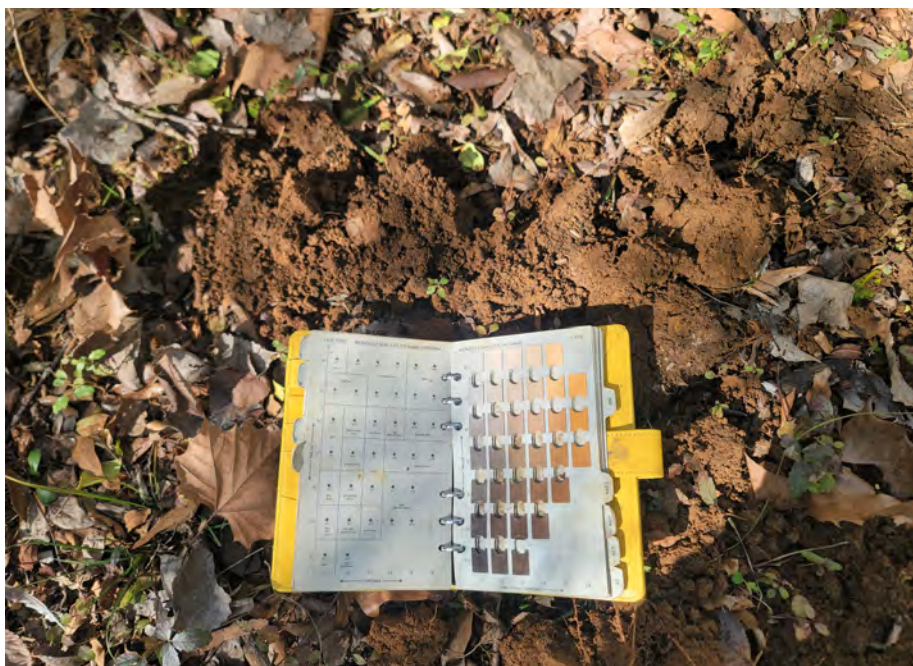
### Plot 10

View of the non-hydric soil profile at Plot 10.
